Contractor Fatality Preliminary Report

Model 703 Bobcat Skid-Steer Loader with Backhoe.

Excavate a shallow trench around a roof drainage pond
(approximately .3 meter /1 foot; .6 meter/2 feet wide)

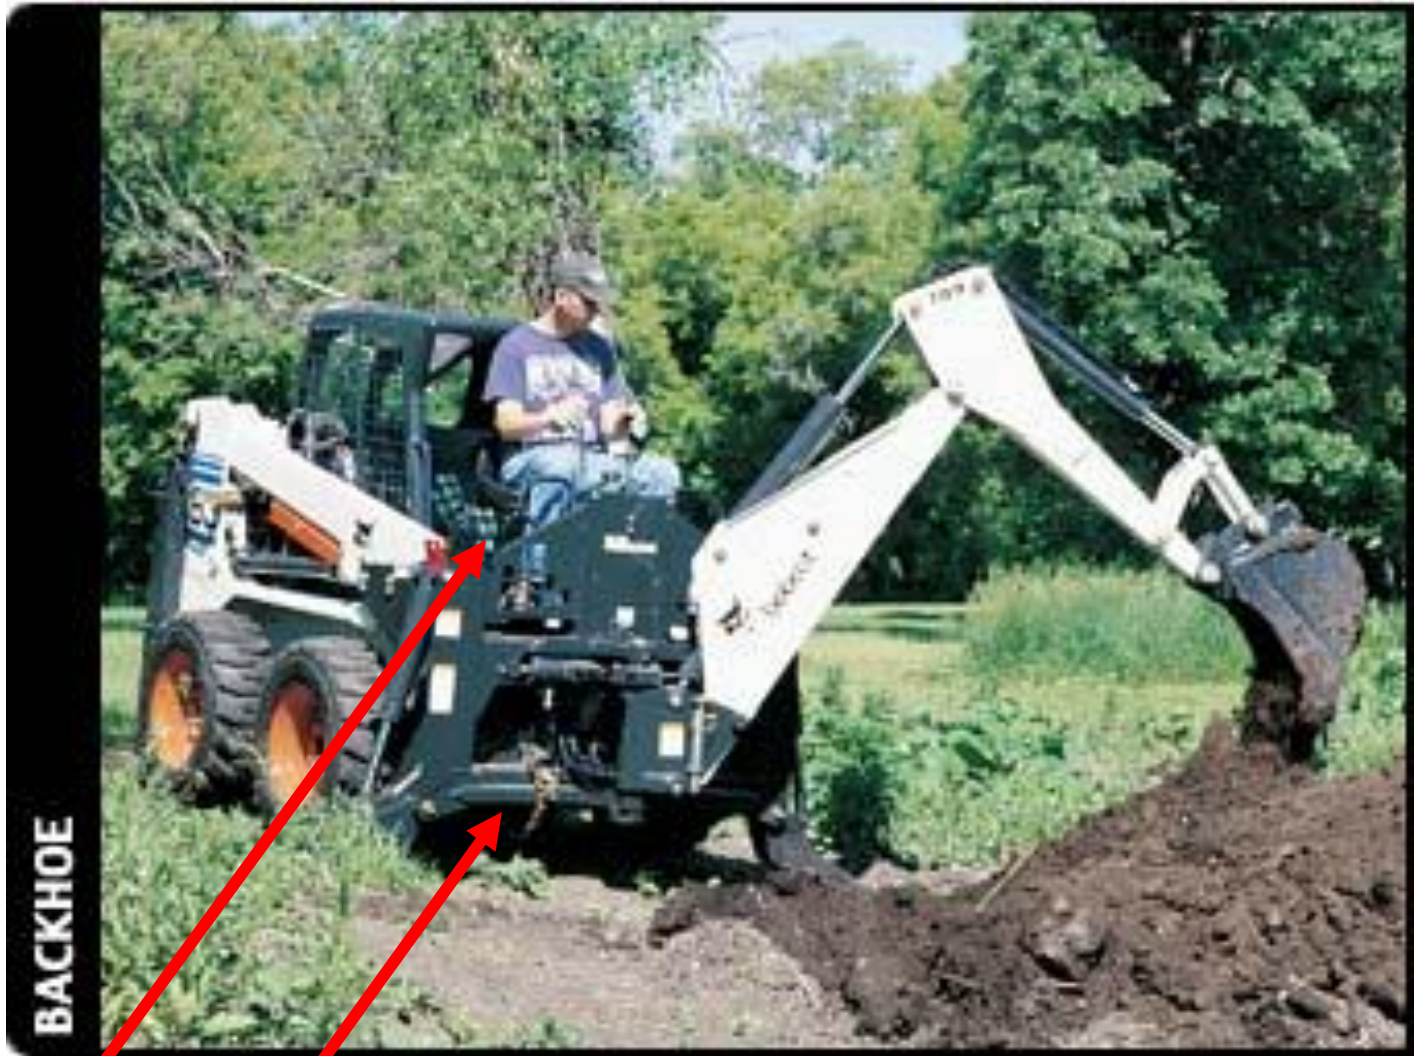
Illustration: Normal position of Bobcat loader with backhoe

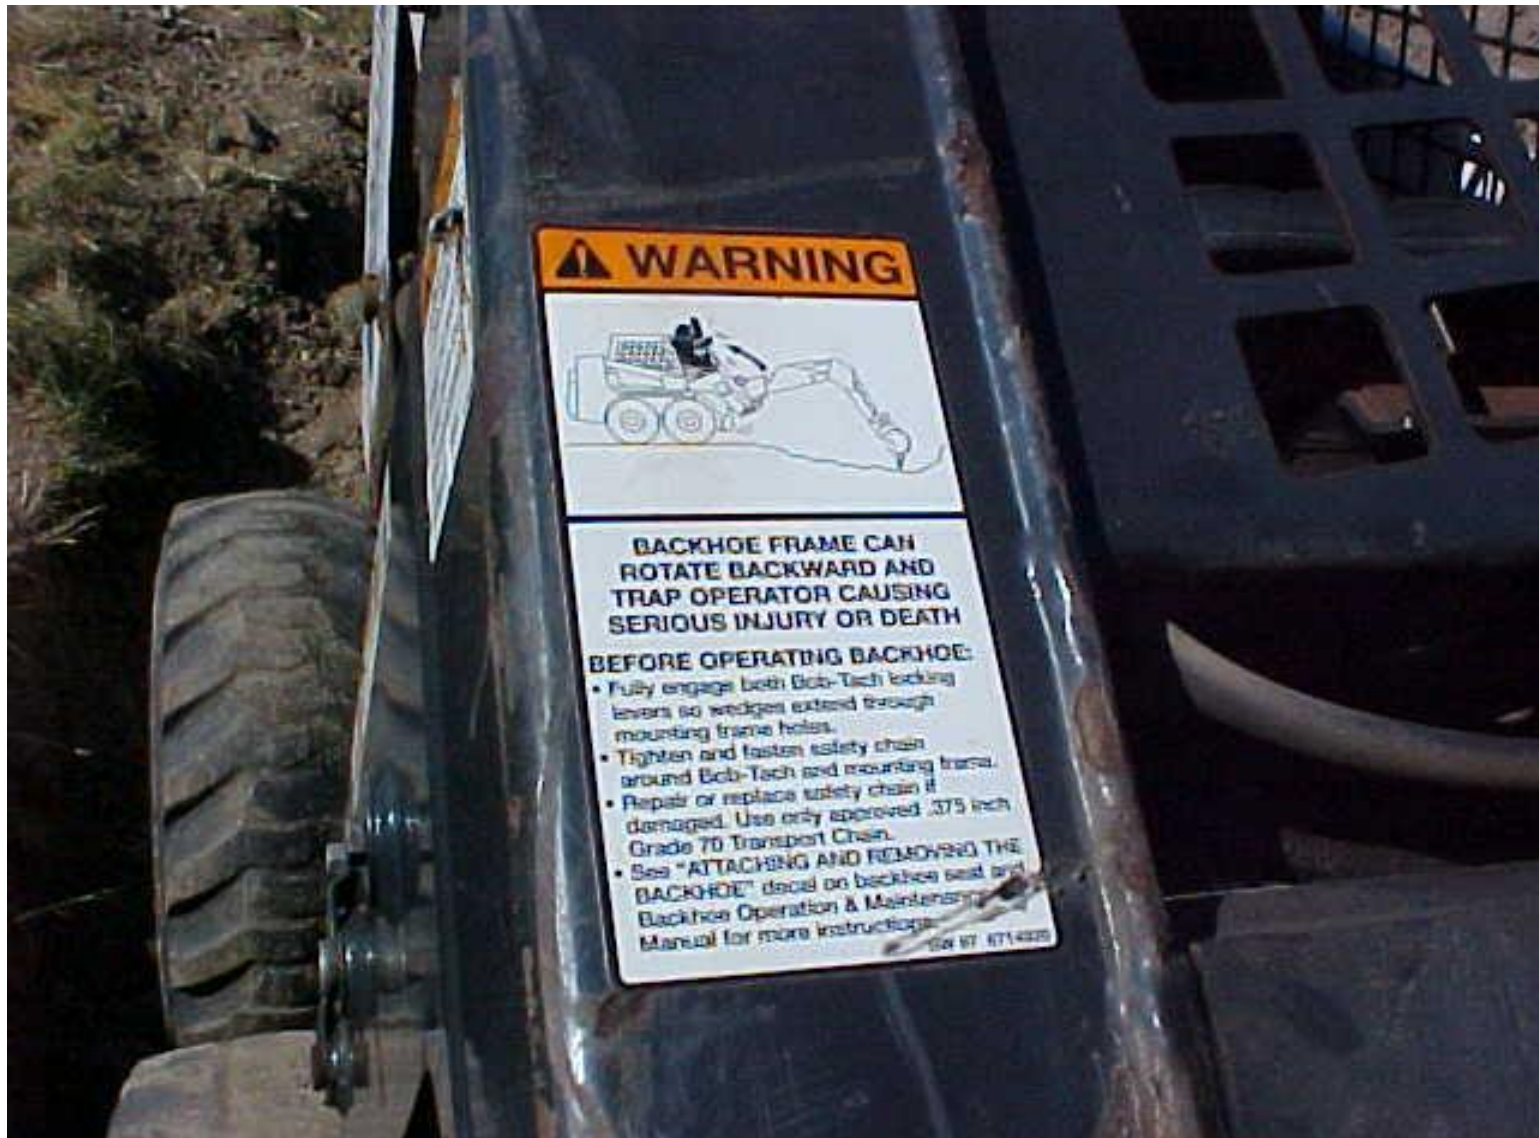
- Safety chain around backhoe and tool bar
- Independent seat and controls in front of cab compartment

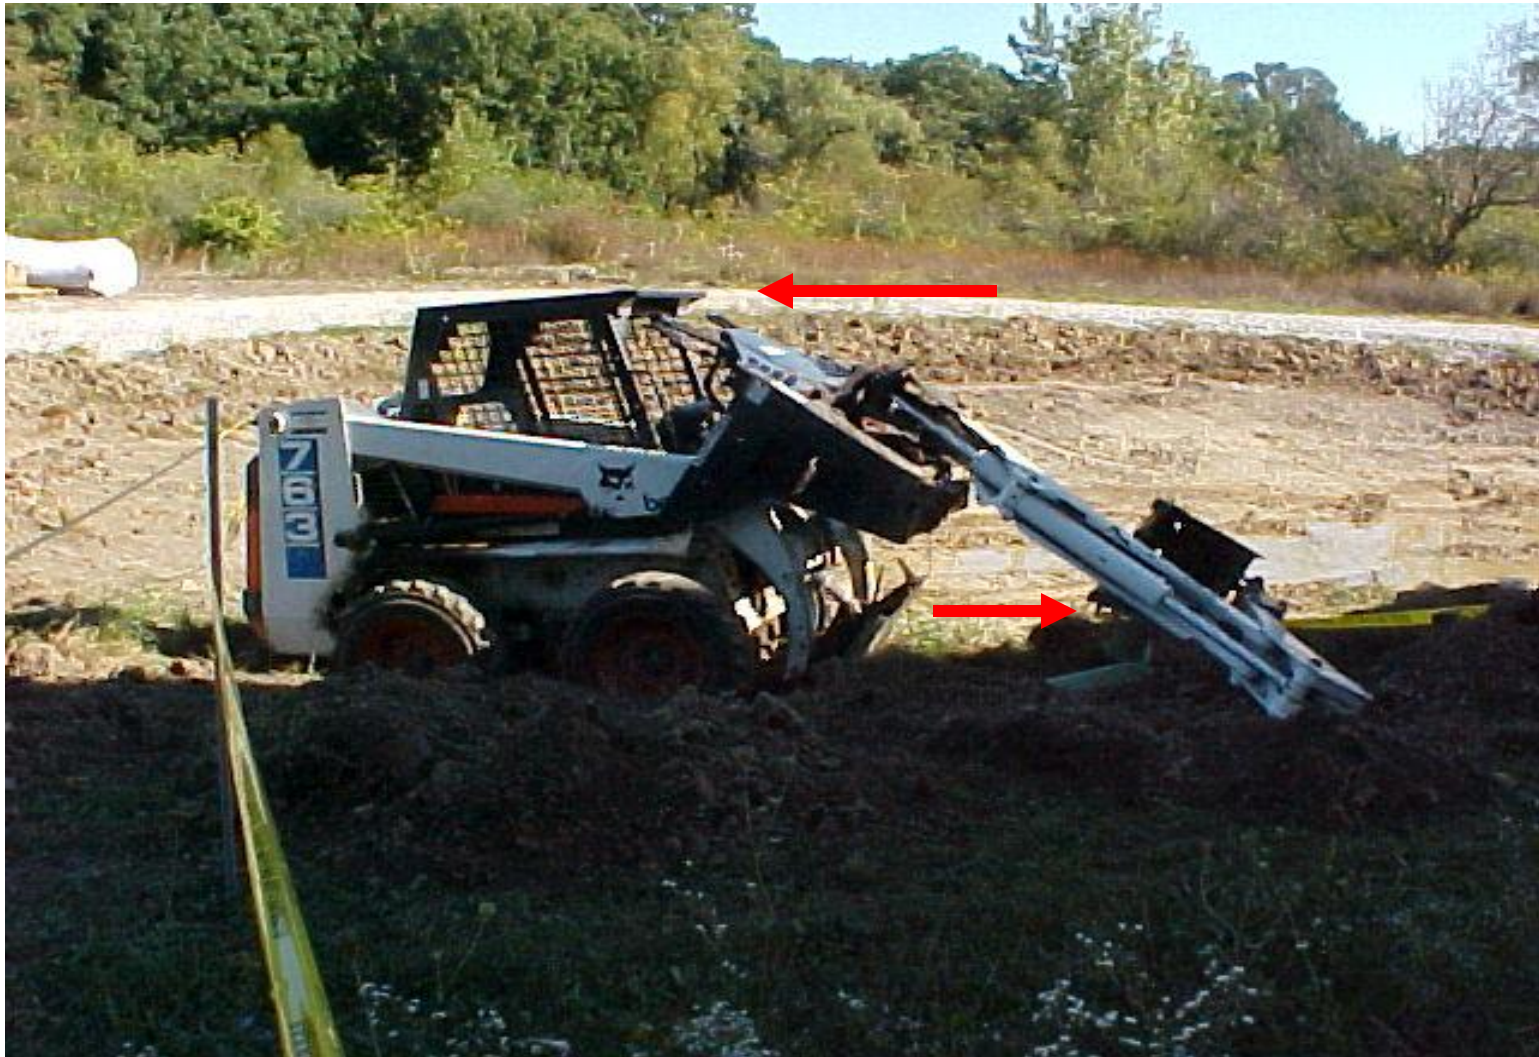
Warning label of the hazard on the equipment

- ❖ Emphasize pre-use inspections to confirm proper installation and condition of equipment
- ❖ Re-emphasize in training the need to properly engage and secure attachments and safety devices
- ❖ Abide by manufacturer's warning labels and Instructions for safe operation of equipment

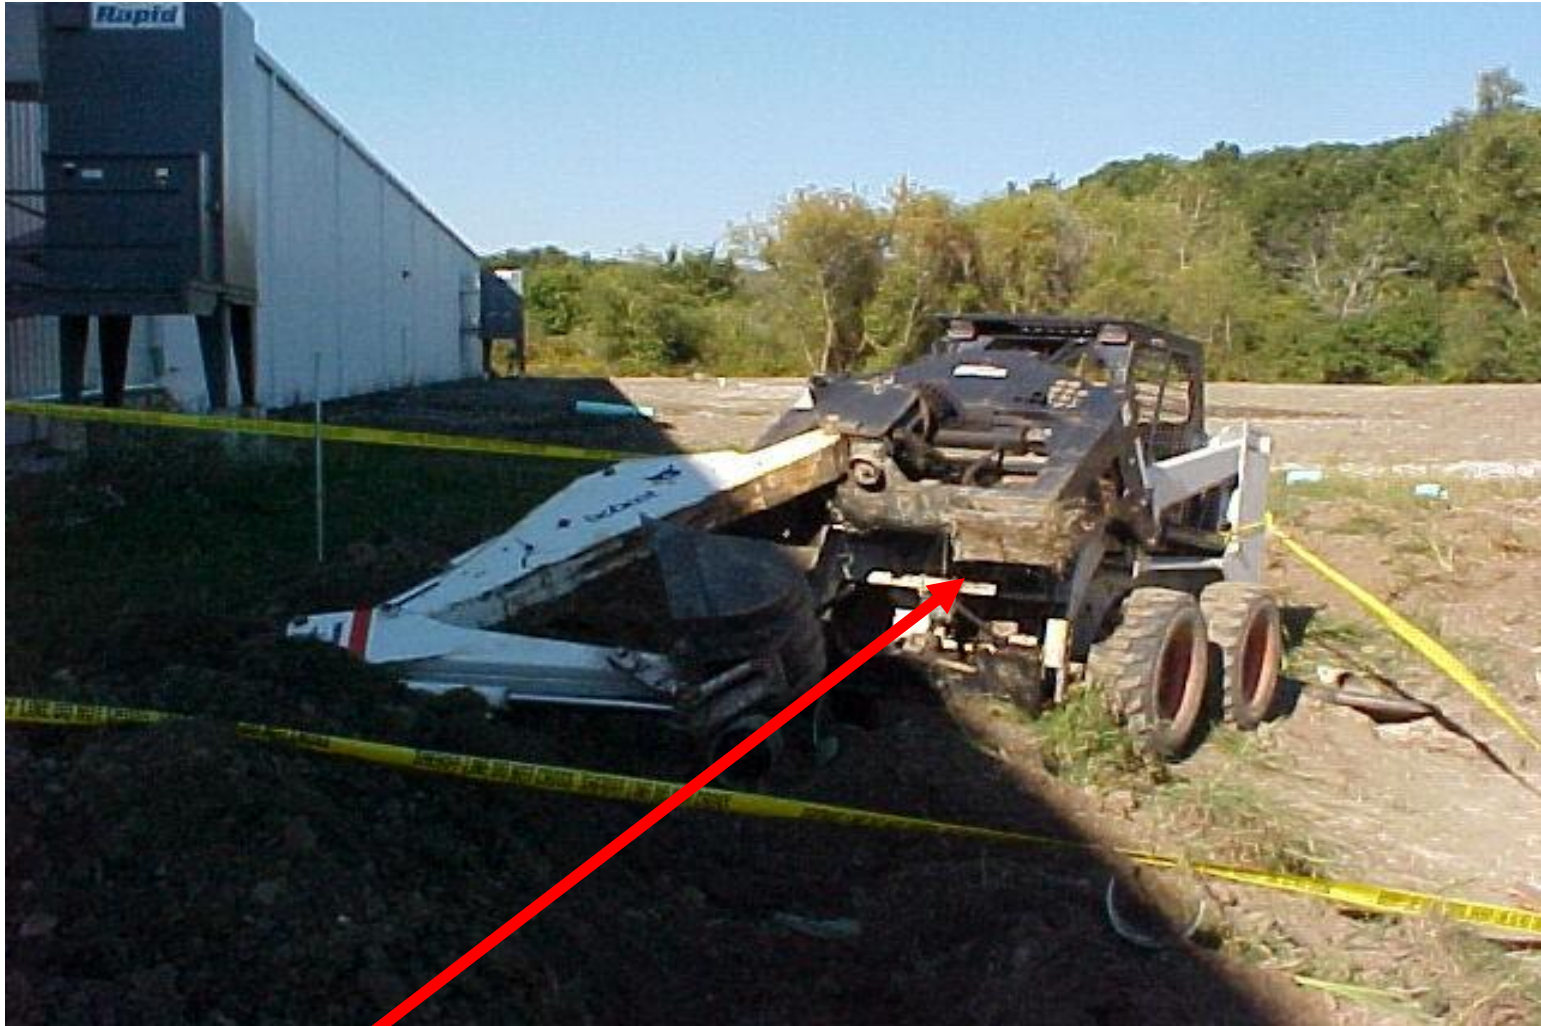
On September 23, 2002, a worker was fatally injured while operating a backhoe attachment on a Bobcat Loader. It appears that during operation, the backhoe attachment rotated backward pinning the upper chest of the operator between a handrail on the backhoe frame and the cab surrounding the normal operating position of the loader.

After incident: Backhoe frame rotated backward into cab

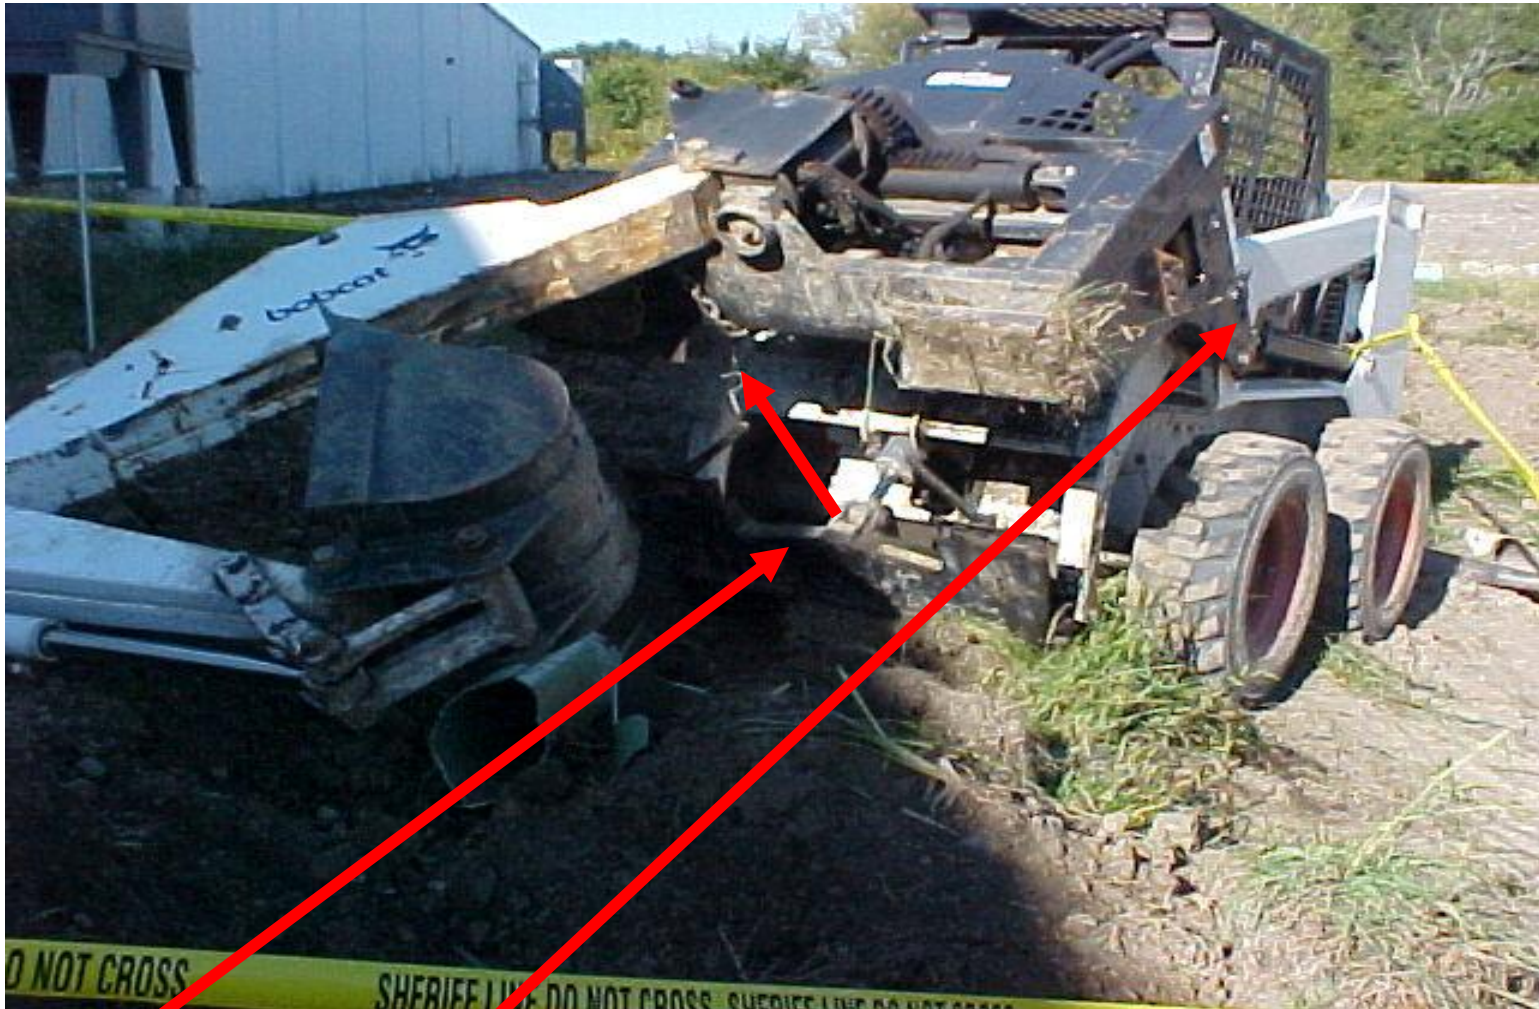
Degree of Rotation: Stabilizers normally perpendicular to the ground

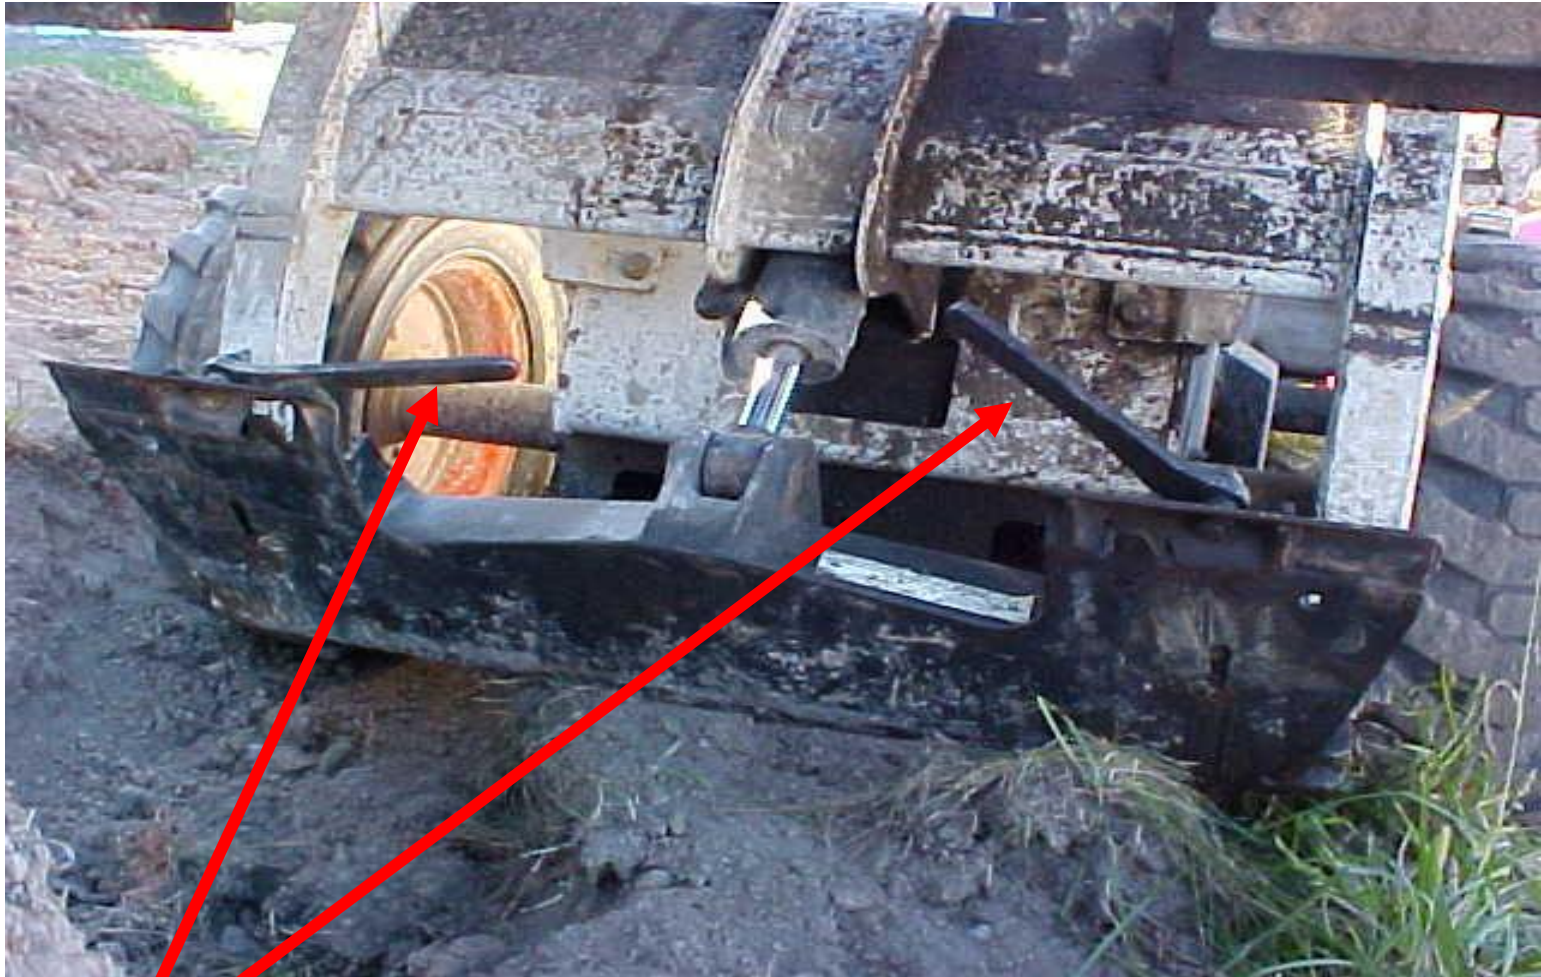
- Upper points of Backhoe attachment engaged
- Lower points of Backhoe attachment not engaged

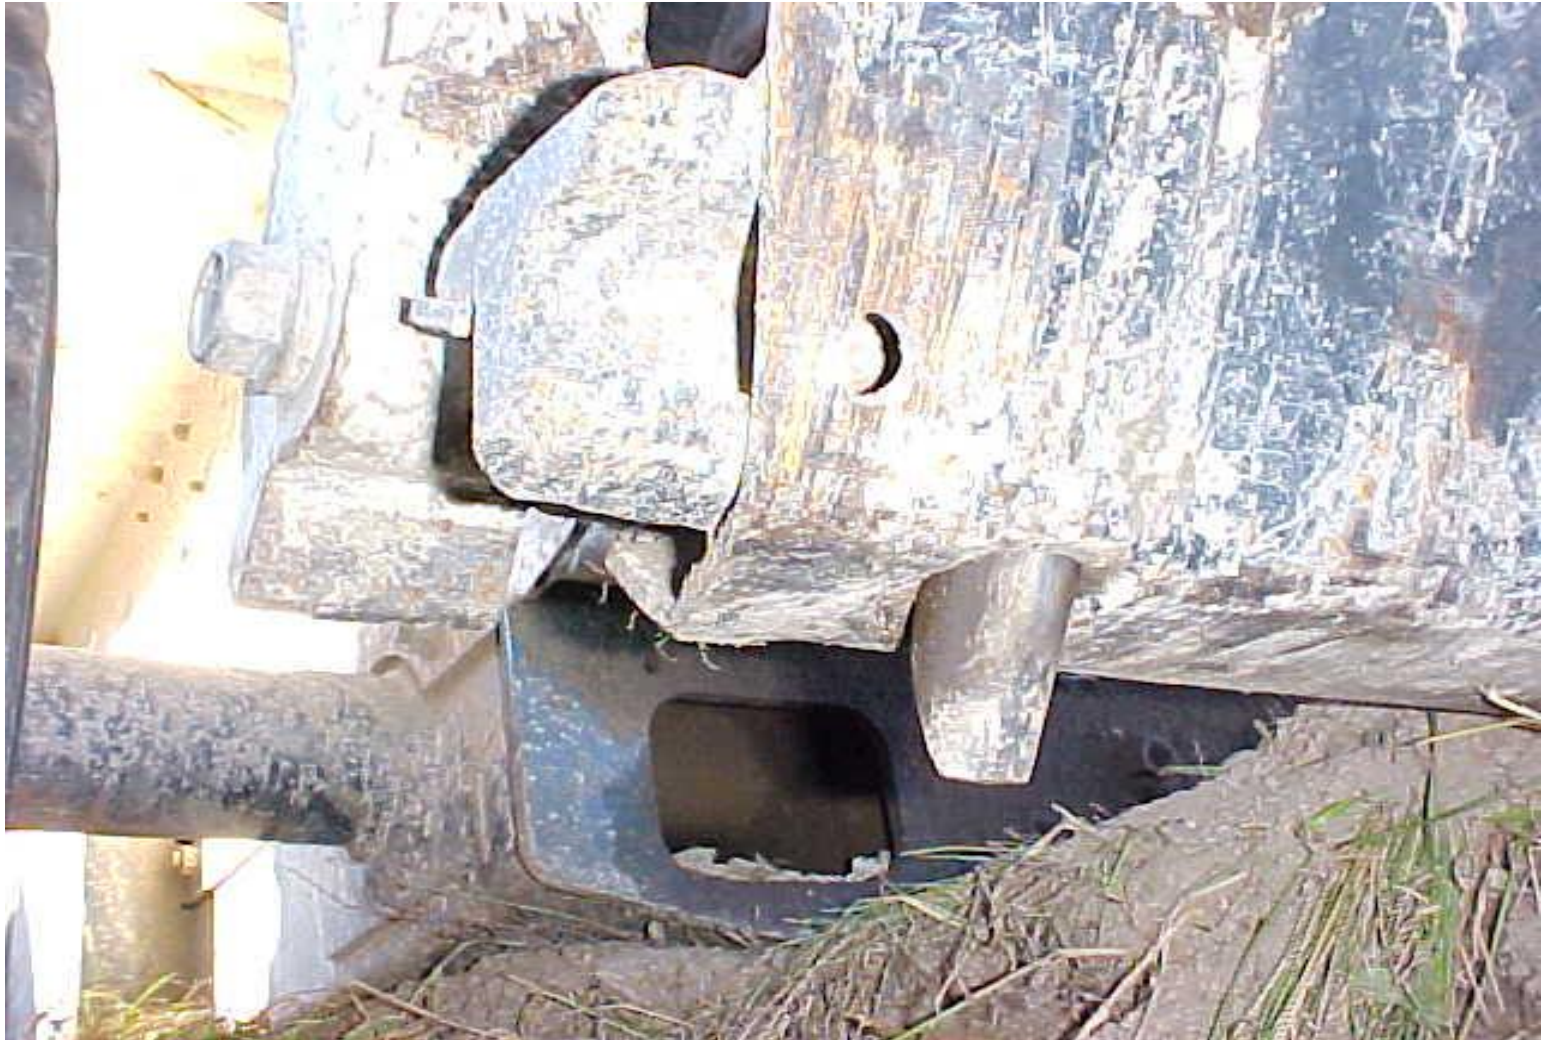
Levers on the tool bar to engage and disengage backhoe locking pins (2) found in a disengaged position after incident

- ✓ The levers for locking pins appeared operational and the locking pins did not appear to be damaged.
- ✓ The safety chain was not broken. It was found to be secured only around the backhoe instead of both the backhoe and tool bar.

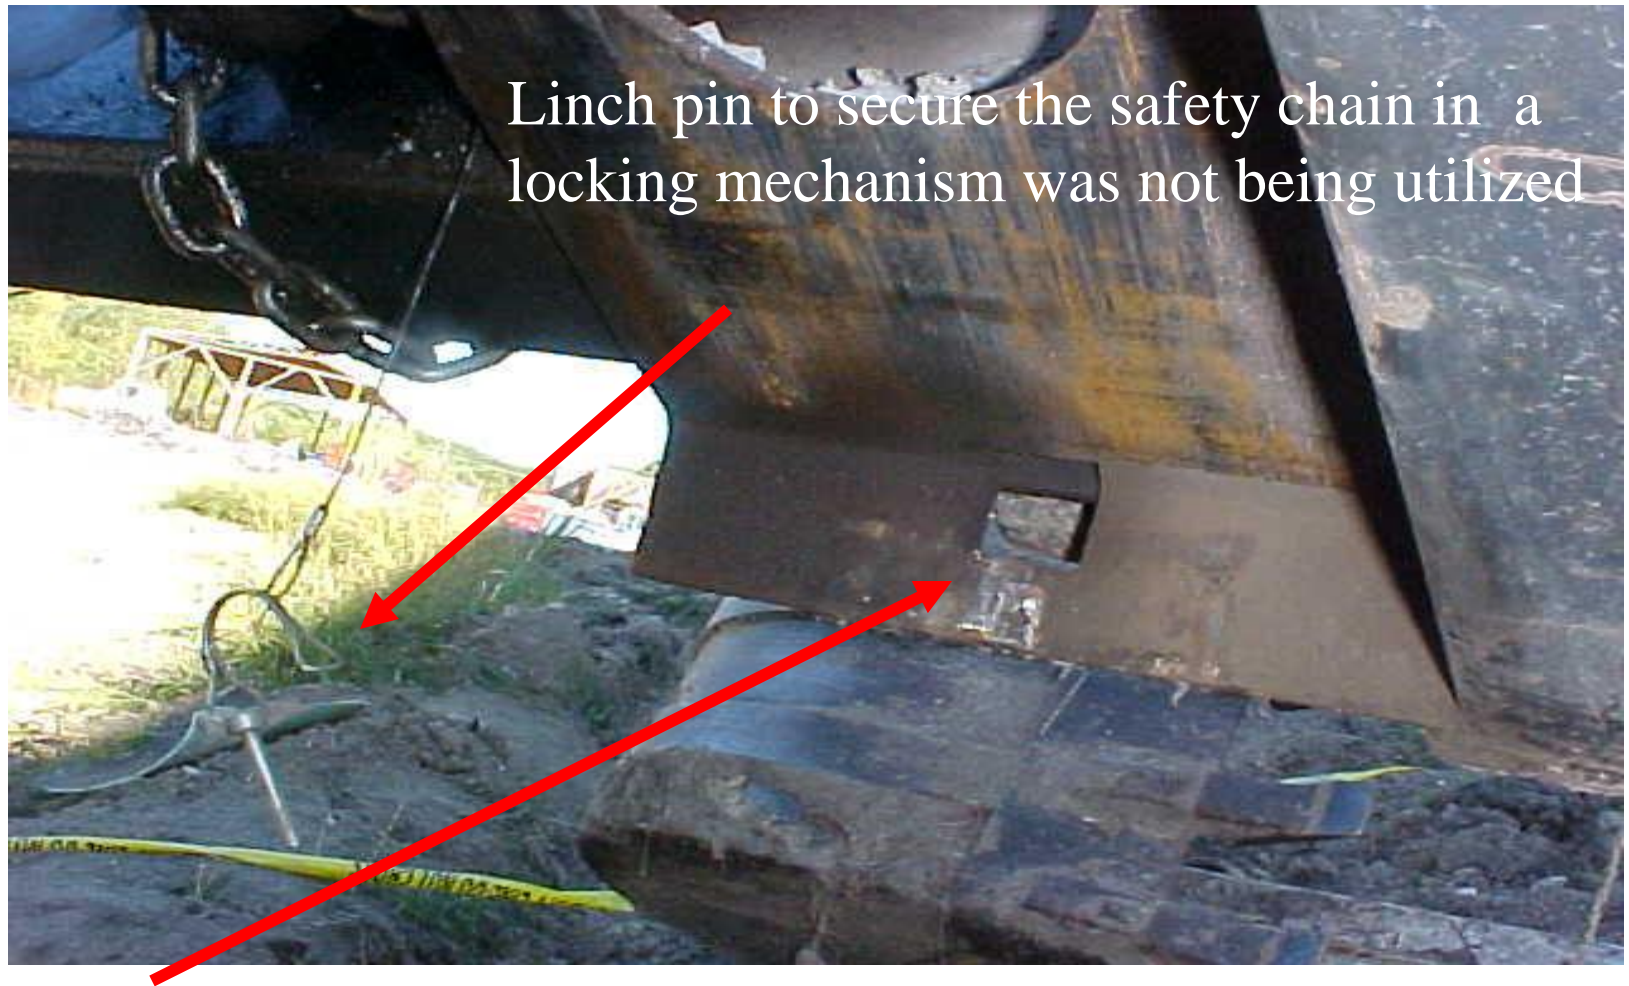
One of the two locking pins in an engaged position.

Note: They were not found in this position after the incident.

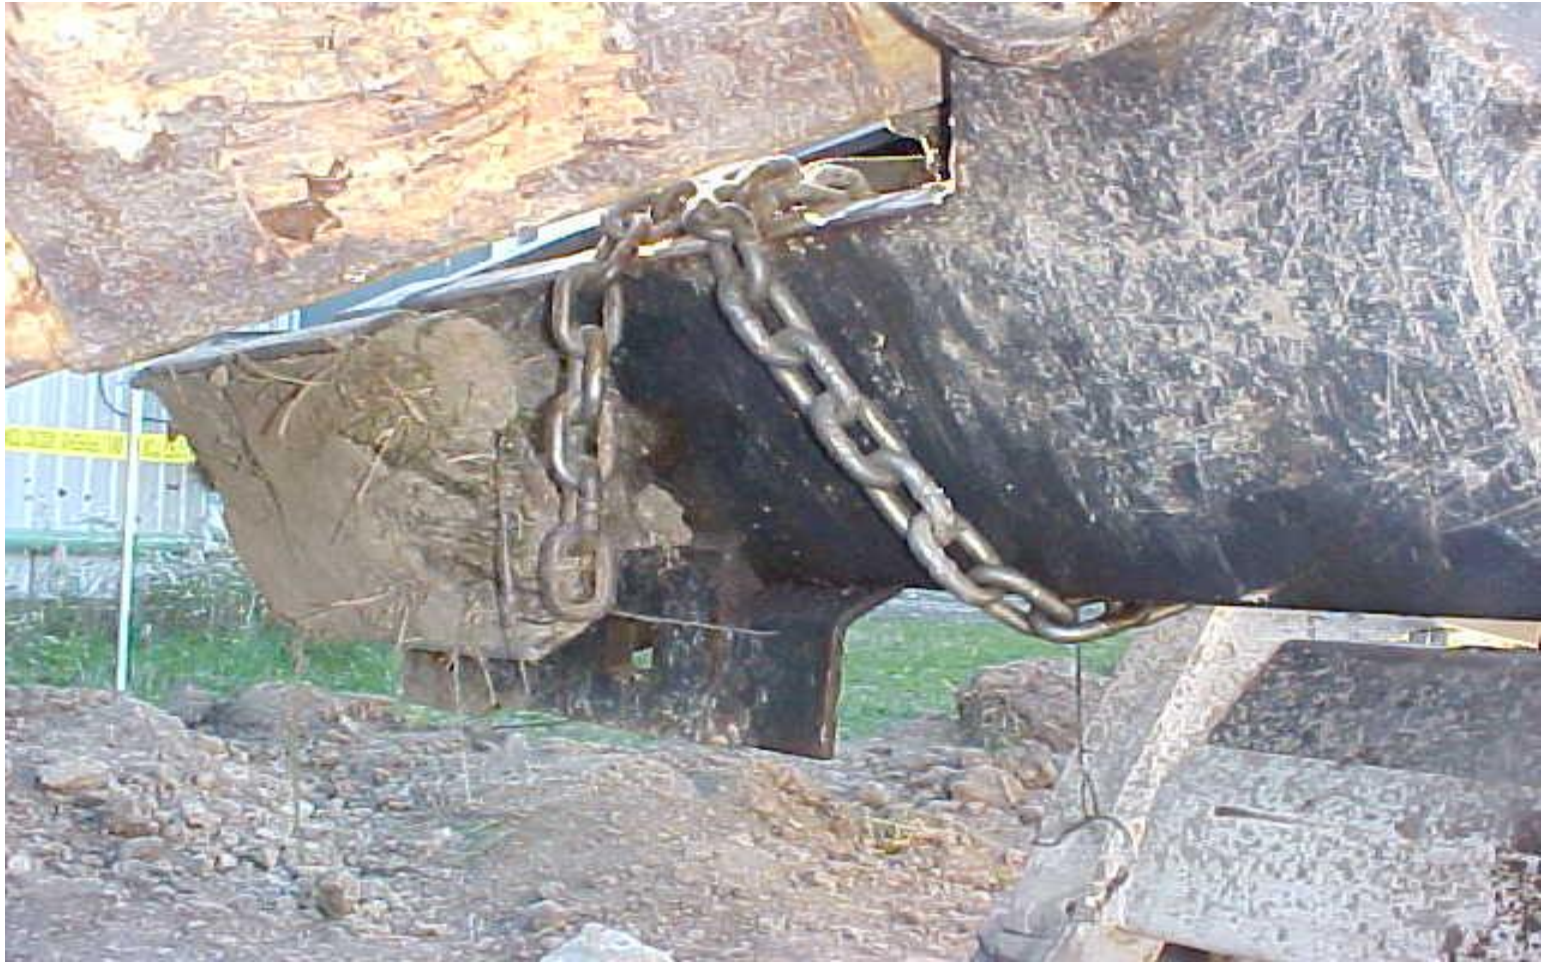
One of the two slots in the Backhoe frame for the locking pins to protrude through and secure the Backhoe to the Tool Bar

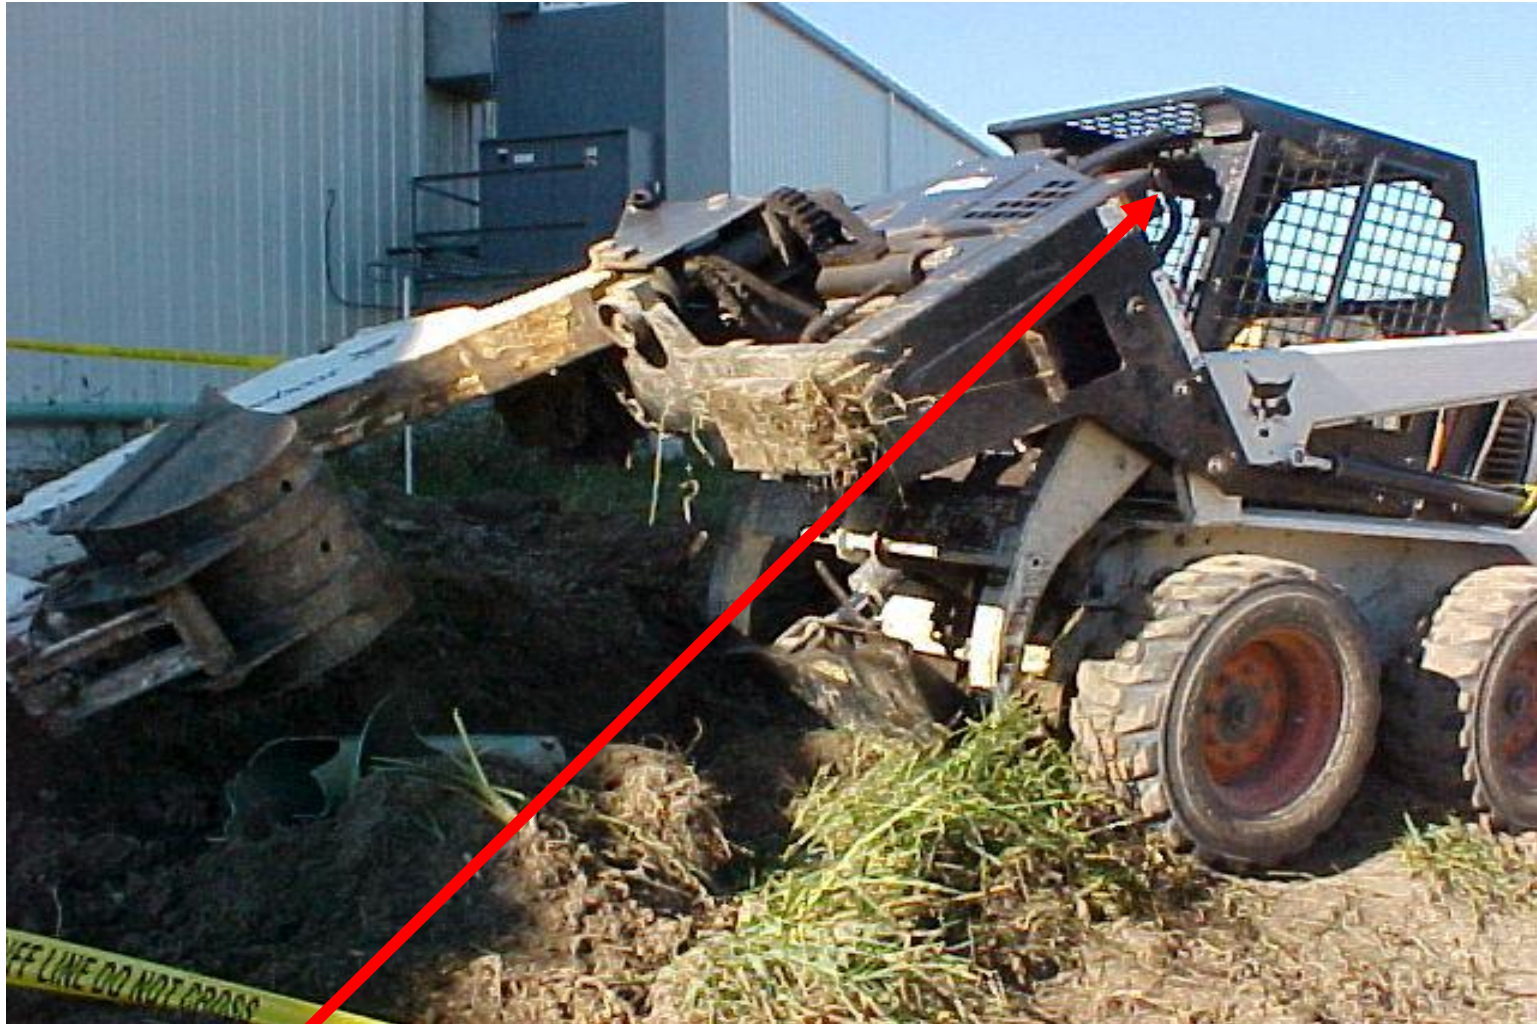
Safety chain secured around the backhoe frame – instead of both the backhoe and Tool Bar. The Safety chain was not broken.

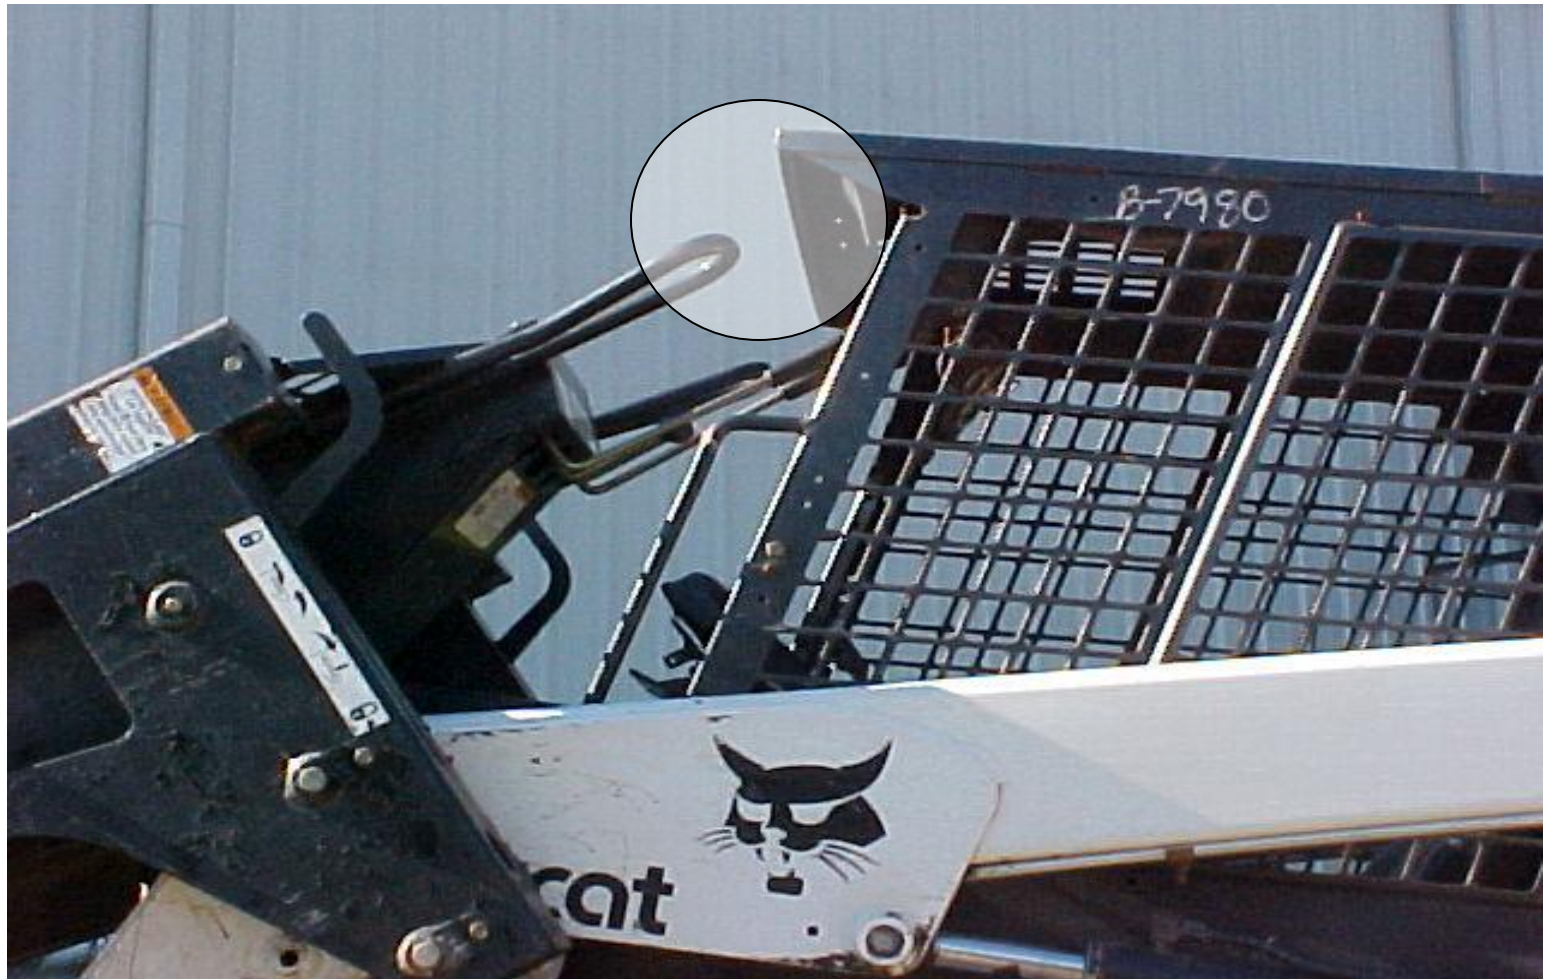
Operator caught between backhoe handrail and cab enclosure

Close-Up of the Pinch point
